Briefing Note 0001 – Batteries and Charging

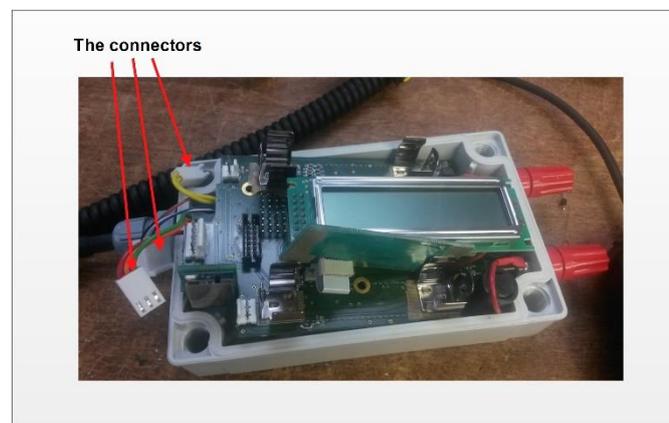
4. Remove the 3 microphone/power connectors.
5. Carefully ease the circuit boards out of the box.

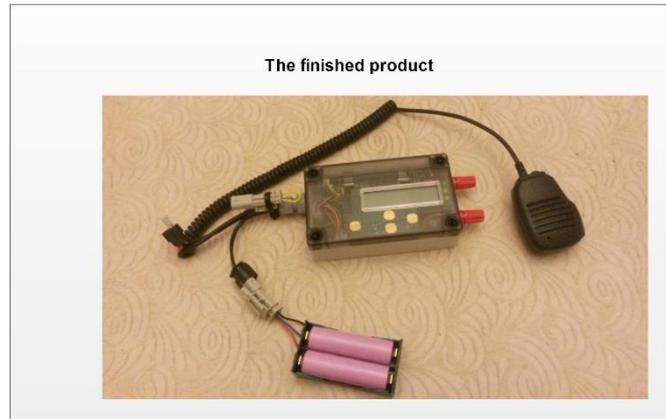
8. Re-build the radio by reversing the above procedure:
 - Replace the circuit boards in the box making sure the nylon spaces are correctly fitted
 - Re-fit the screws holding the circuit board
 - Re-fit the microphone and power connectors
 - Optionally replace the internal batteries
 - Replace the lid
